Fault Finding

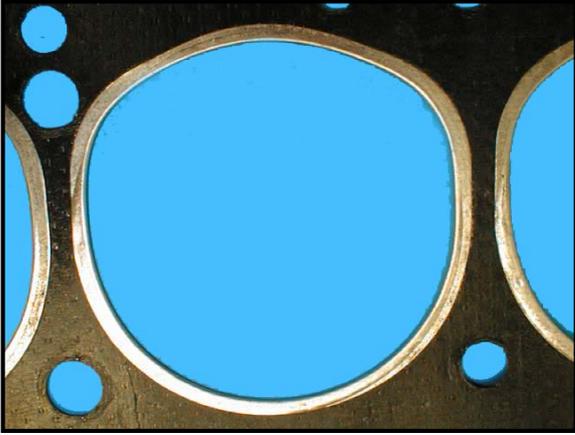
INCORRECT APPLICATION

Underside of all fire rings (i.e. block side) exhibit distinct impressions where pistons have hit the head gasket.

Head gasket incorrect for application.

Several Vehicle Manufacturers produce small & large series engines using the same basic engine but with varying size cylinder bores.

It is thus essential that during head gasket replacement the fitter ensures that the gasket fire rings are circumferentially clear of the bore, normally 1mm to 3mm on diameter.

Under no circumstances must the gasket fire ring bores overhang the cylinder bores.

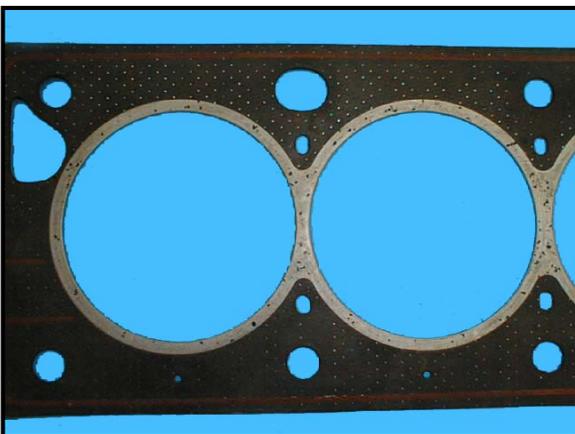
DIRTY ASSEMBLY

Foreign particles trapped and crushed into the fire ring faces and composite facings.

Particles dropping from water galleries during placement of head.

Since the cylinder head is normally dry when being re-installed it is possible for rust deposits and similar contaminants to detach and fall from the water galleries onto the head gasket. These particles can create gutter paths for combustion gases which will quickly burn back into adjacent bore or water galleries etc.

We suggest thorough flushing of the head, preferably with detergent and a high pressure washer followed by additional airline cleaning. Only fit the cylinder head when confident that no further media is falling from the water gallery portings.

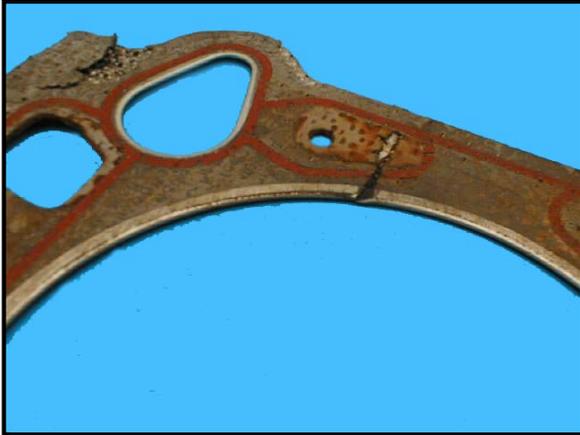
PARTICLE ENTRAPMENT

Deep trough in fire ring with blackened gutter path into water way.

Large particle entrapment on assembly.

As per previous feature "Dirty Assembly". In this example the dirt particle was extremely large promoting the gutter path to form very quickly. Gutter paths can similarly develop if block or head facings have localised low spots. Lack of fire ring clamp at a low spot will allow high pressure / high temperature gases to enter the gasket composite backing material and burn back will quickly occur.

Ensure cleanliness of assembly. As a minimal precaution have the head refaced and if practical reface block also. Checking a cylinder head / block face with a straight edge is not an effective method of proving flatness.

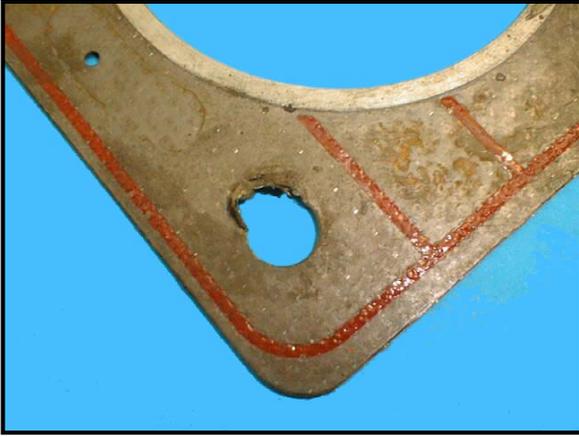
POOR LOCATION

Two or more stud / bolt holes pulled and galled.

Poor location of gasket or movement of same during assembly.

If an engine has head locating dowels then this problem will not occur. However, always ensure that dowels are in good condition and correctly located. Many engines rely on the head bolts / studs to locate both the gasket and the head. In this case we recommend the following:

Heads which are located by studs can present problems particularly if "spring" exists when assembled to block. Sliding the head gasket over the studs sometimes creates tight assembly and head gasket distortion and hole galling can occur. Where practical it pays to place the head gasket on the block and screw the studs in through the gasket into the block. A light smear of grease on the assembled studs will help the head slide precisely down into position.

If possible it is advisable to make up and employ two diagonally opposed studs in which to guide the head down onto the head gasket. Lightly screw in the remaining head bolts before finally replacing the studs. This is particularly easy if replacing stretch bolts as you simply cut the heads off two old bolts & hacksaw in screwdriver slots for ease of removal. This method is essential when fitting the cylinder head on a Rover "K" Series engine. Any side manoeuvring of these heads can cut & seriously impair the silicone beading on the head gasket.

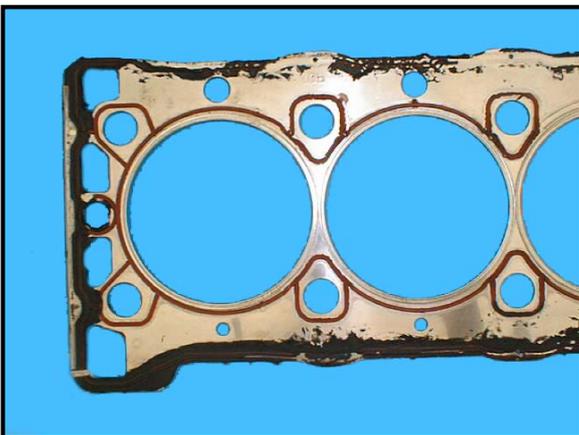
APPLIED SEALER

Unightly and Unprofessionally applied sealer.

Incorrect application of sealer.

Gaskets should be fitted as supplied. A very light application of non-hardening sealer can be applied around oil gallery eyelets keeping away from actual hole centre, (not Rover "K" Series). We emphasize light application as only a smear should be applied. Assembly of parts should be immediate to prevent solidification of the applied compound. If sealer is applied generally to a gasket then you are actually jacking the block and head faces away from the gasket. Lack of crush / clamp to the fire ring will result and gasket failure will be very quick.

Follow Gasket Manufacturer / Supplier instructions and use sealers only when recommended.

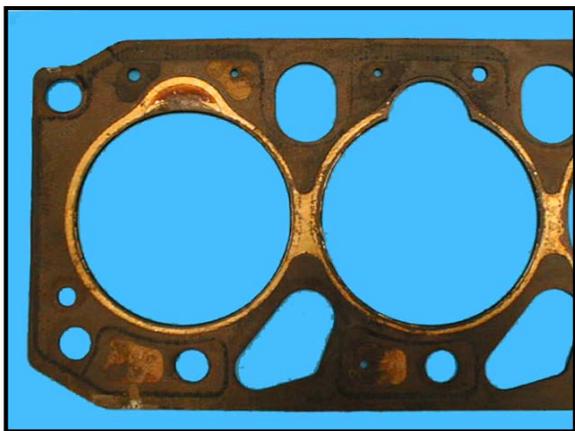
MISSING PRE-COMBUSTION SUPPORT / PAD / HEAT SHIELD

Semi-circular cut out in fire ring bore.

Loose pre-combustion chamber.

Diesel engined motor cars in recent years have become common place throughout Europe. Indirect injection engine feature "Ricardo Chambers" or "Pre-combustion Inserts" where the initial detonation charge is fired. These chambers are only an interference fit in the cylinder head face and over a period of time can become loose. Detonation chatter can then cause the loose chamber to cut its way through the gasket to total destruction. Further block face damage & certain damage to the head will result.

When replacing a head gasket take professional advice as to tightness of pre-combustion chamber. Replacement of same or fitment of oversize units can prevent detonation chatter and the possibility of a complete engine change.

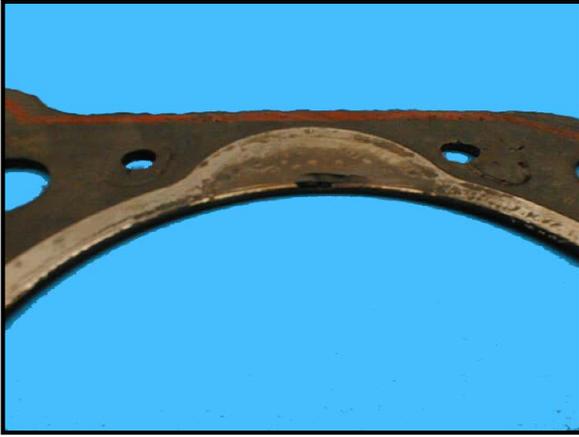
SPLIT RICARDO PAD

Edge of fire ring / Ricardo pad is burnt through with extending circumferential cracks.

Incorrect detonation.

This type of failure is normally attributed to inefficiency of burn. Many factors can be responsible and the advice and attention of a diesel specialist should be sought.

- (A) Faulty Injector
- (B) Faulty injector pump
- (C) Incorrect pump timing
- (D) Added factor of overheating

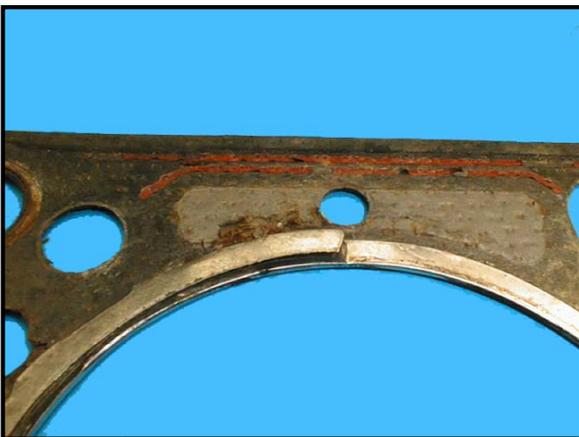
CIRCUMFERENTIAL SPLIT

Fire ring split on the immediate inner circle. Sometimes accompanied with a radial split as per photo.

- (a) Lack of clamp.
- (b) Incorrect diesel detonation.

(a) Lack of clamp allows the fire ring to expand and contract beyond the control clamp of the head and block. This excess movement promotes work hardening and a brittle fatigue crack results. Burn back and ingress of combustion / compression gases into neighbouring ports soon develops to engine failure.

(b) Incorrect detonation on diesel engines can result in this type of failure. A combination of excess heat, extreme pressures and ultra-sonics result in this brittle fatigue crack.

(a) Ensure head and block faces are flat and to the correct surface finish. If required fit new stretch bolts and strictly follow tightening procedures. Cooling systems must be checked and efficiency proven.

(b) Excess smoking or suspect performance of a diesel engine should be addressed by a diesel specialist.

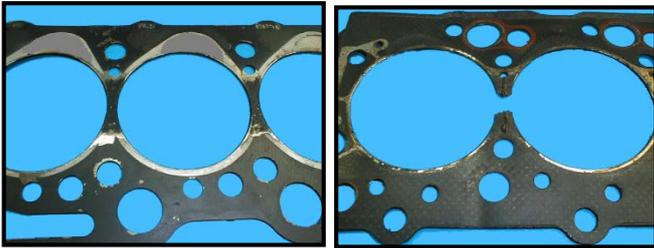
CENTRE BRIDGE BURN

Note blackening between bores which progress to burn through failure as in second photo.

(a) Inherent distortion of head or block denying lack of clamp between bores.

(b) Distortion due to overheating.

Cylinder heads normally distort forming longitudinal low bridge between all bores. Combustion gases escape into the adjacent cylinder and vice versa on the next stroke. This concentrated heat flow burns the fire ring bridge away to point of dramatic power loss.

Follow gasket manufacturer / supplier fitting recommendations and reface head and block as a matter of course. If called for address any cooling inefficiencies. Always fit new cylinder head stretch bolts and strictly follow tightening procedures.

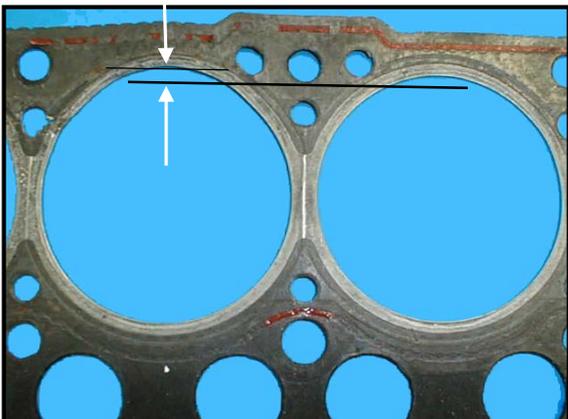
CIRCUMFERENTIAL SHIFT

Note outward displacement of left hand bore & rupture of top outer gasket edge.

Isolated lack of clamp.

In this example the left hand bore has distorted and shifted outwards due to lack of clamp caused by a sunken liner. Compression gases have then ingressed into the left hand water gallery at which point overheating has taken place.

Follow basic procedures ensuring flatness of head and block faces. Where a block has wet liners it is advisable to check liner protrusions against manufacturer's specifications. In all cases liners must protrude by the same amount and preferably to the maximum limit. As a general rule liners must protrude by a minimum of 0.002" / 0.05mm or ideally to the manufacturer's recommended highest limit.
