CARBON FOULING

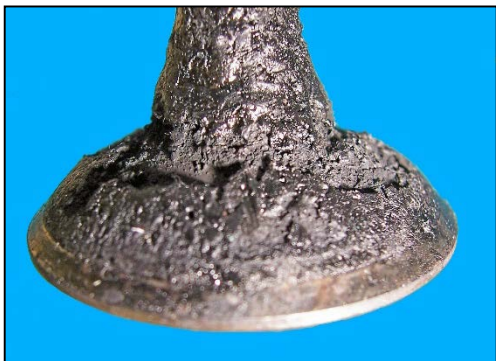
Heavy encrusted black deposit resembling "coke". Substance can be wet and oily to the touch.

- a) Loose or ineffective valve stem seals.
- b) Worn valve guides.

a) During an engine's life it is quite normal for valve stem seals to harden/perish and lose their ability to wipe excessive oil drain from the valve stem.

b) Excessive valve guide wear/valve stem wear, produces a side to side movement between the sliding surfaces and a pumping action can be produced. This is especially so on inlet valves. Similarly the side movement ovaliates the stem seal lip encouraging oil by pass and encourages stem seal wear. With added gravitational and induction pressures, excessive oil runs down the stem and although some enters the combustion cycle to be witnessed as "blue smoke", the residual flow bakes on the valve throat and solidifies. This invasive contamination will reduce the breathing ability of the engine and breakaway particles can become trapped between the valve face and seat. Some valve designs incorporate a "carbon breaker" groove on the stem which prevents carbon fouling but only at that point.

During engine overhauls it is of prime importance to measure valve stems and valve guide bores for size consistency and to ensure the valve guide clearance is held with the manufacturer's specification or as per the size chart recommendations which can be found in our fitting suggestions for valves.

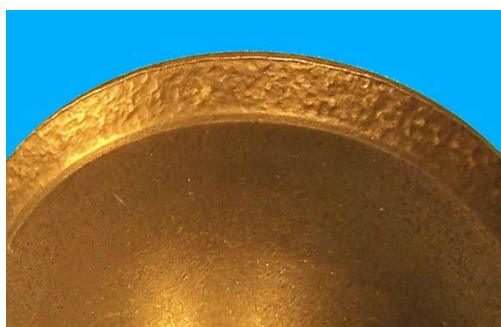
SEAT PITTING

Valve and valve seat are peppered with tiny craters resembling the "moon's surface".

Primarily contaminant fouling temporarily trapped between the valve face and seat which encourages hot gas blow by/acid etching/metal tongue detachment and adhesions.

Basically there are many reasons which can instigate the failure of a valve and seat facing. These can include face damage due to incorrect valve lapping/valve and seat eccentricity/valve guide wear/ingress of excessive oil producing carbon fouling/overheating for whatever reason i.e. tuning/coolant deficiencies etc. Valve seatings in this condition can only deteriorate further with the possibility of a "vee" section burn out caused by a concentrated "gutter path".

Valve seating is of prime importance and we recommend strict adherence to our seating suggestions. The general use of lapping paste is to be strongly discouraged and all seating dimensions must be within manufacturer's tolerances. By following our seating suggestions natural face peening will produce a polished face with air tight sealing.

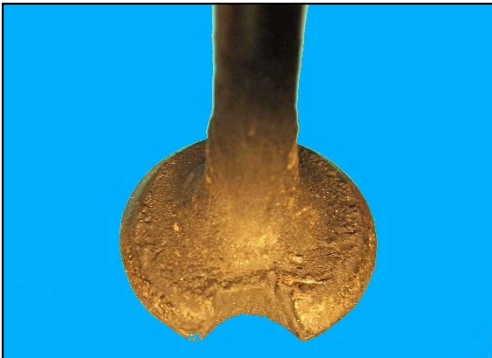
GUTTER PATH

A "vee" section is missing from the valve head causing compression loss. The engine would be very "lumpy" and backfiring from the exhaust might be evident.

Material loss has been caused by "melt" during attempted combustion/firing stroke. This gutter path failure could also initiate valve seat cracking.

By referring to the previous two valve heads featuring "carbon fouling" and "seat pitting," it can be easily imagined that due to the lack of air tight sealing on the seat faces that hot gases can escape the combustion chamber and by pass the valve. In design, the head of the valve conducts combustion heat into the margin and the throat and then into the valve stem and guide. Similarly valve face heat is conducted to the cylinder head valve seat. Both of these component terms are adjacent to the coolant channellings, where the heat is finally absorbed. Where seating is damaged these hot gases can escape past the seat facings and temperatures as high as 1650 C degrees can be experienced. If gases are encouraged and channelled to one place i.e. the widest seal loss gap, then the valve and even the seat can gradually melt and tiny spheroidal molten metal is eroded away. A "gutter path" for the hot gases is thus formed and the metal loss will progress to a "vee" section. Pre-ignition due to tuning deficiencies will also accelerate this process.

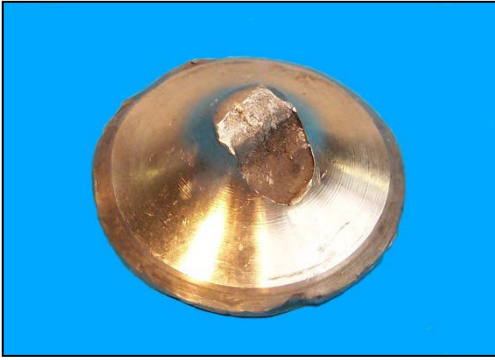
DETACHED VALVE HEAD

Valve head breaks adjacent to the stem and throat join.

- a) High seating forces.
- b) Valve and piston collision.

a) Although extremely rare, it is possible for high seating forces to initiate fatigue stresses at the true stem adjacent to the valve head throat. High seating forces can be simply due to over revving which encourages valve bounce, or by badly worn valve guides or thick seat contaminants which force the valve to double close. A valve that is constrained at an angle which is hostile to the valve guide centre line will hit one side of the valve seat and then bounce to attempted closure on the opposite side. This creates a side loading of the valve head. Accordingly the stem being the narrowest point will give rise to a natural fatigue point. Molecular movement and work hardening will result in a valve head detachment with massive consequential damages.

b) Valve and piston collision can be simply due to mistiming either by human error or for instance a timing belt break. A valve that is inclined at an angle to the piston travel will readily break due to the side impact imposed. Valves which operate in the same axis of the piston travel can sometimes escape breakage particularly if a rocker arm breaks, however the valve head and stem will have suffered some dimensional misalignment and must be replaced.

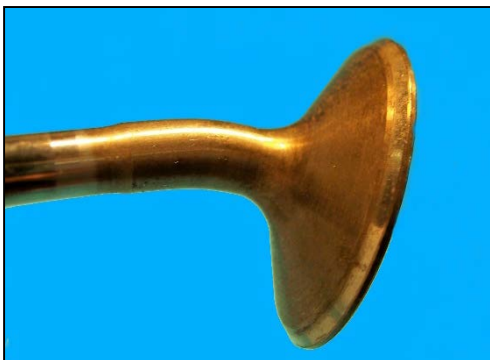
BENT VALVES

Head is bent from the true stem axis.

Piston and valve collision.

Normally a timing failure will result in catastrophic damage within the combustion chamber i.e. Valve/piston/combustion chamber faces and even the cylinder bore wall. Consequential damage can also be transmitted to connecting rods, camshafts, camshaft housings and camshaft followers. During repair work for such a failure, valve guides must be checked thoroughly for chipped ends and longitudinal cracks and be replaced as necessary. A bent valve must never be straightened as invisible defects can give rise to fatigue failures resulting in a future engine breakdown.

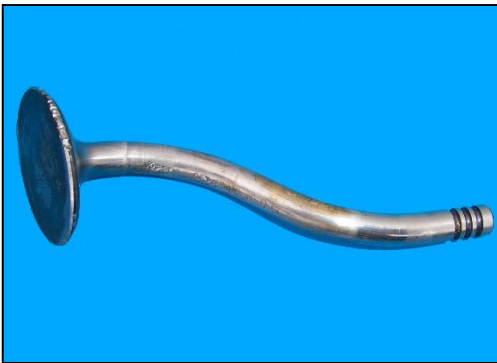
DROPPED VALVE

Entire valve drops into its respective engine cylinder.

A dropped valve is where the valve is not constrained by the valve cap and cotters. The retainer release allows the valve to gravitate and even be accelerated under camshaft lift into the cylinder bore where major damage is inevitable. There are several circumstances that can cause this including;-

- 1) Incorrectly fitted cotters allowing them to jump out on initial start-up.
 - 2) Worn cotters and/or valve cap.
 - 3) Cracked valve cap.
 - 4) Seized valve stem in a valve open position which allows an unconstrained rocker arm to strike the side of the valve cap releasing the cotters.
 - 5) Breakage of valve stem adjacent to underside of cotters due to excessive side way forces imposed on the stem i.e. worn valve guides, out of square valve springs or even excessive valve clearances which create valve stem hammer.
-

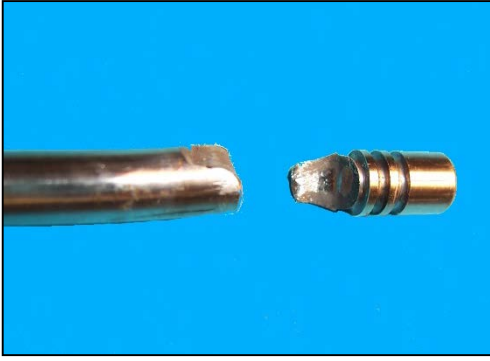
COTTER / STEM BREAKAGE

Valve stem breaks immediately at the lowest cotter groove.

Incorrectly seated valve spring.

This phenomenon is particularly prevalent at present times with Audi/VW group 4 cylinder 20 valve engines. These engines have a history of suffering major engine damage which is evident very shortly following aftermarket repairs to the cylinder head. However the following principles applies to any cylinder head. During cylinder head overhauls/repairs, it is very important to be aware of the following assembly procedure;-

1) The valve springs sit and locate in recessed housings which are approximately 3mm deep compared to that of the surrounding oil bath casting. In fact, the raised casting is quite rough and in some instances we have witnessed casting irregularities as high as 5mm. The spring has very little side clearance when it is located in its recess and in view of the awkward accessibility and the inability to see properly, it is all too easy to misplace the spring on to the edge of the raised casting. In other words the spring attempts to seat partly in the proper recess but also partly on the high surrounding casting. When assembled we now have two constraints on the valve which are acting against one another. 1) The valve guide is constraining the stem to the centre line axis of the guide whereas 2) the valve spring is attempting to similarly constrain the valve stem to the centre line of the free spring. This results in a high side loading of the valve stem. The following diagrams illustrate the forces and effect which are dramatically increased during camshaft lift and valve open.

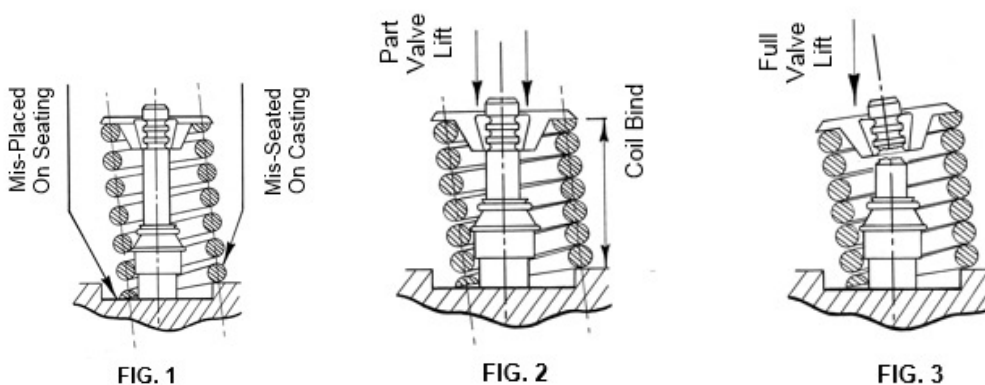
The spring is misplaced half on the raised casting and half in its correct recess. This results in the spring sitting at an angle to the valve axis.

During the valve opening sequence the spring (in the worst scenario) coil binds preventing further free valve lift.

The coil bind acts as a pivot point for the valve cap and further camshaft lift still pushes the valve and free side of the spring down resulting in a tremendous bending moment. The lowest cotter groove being the closest minor diameter and being a natural fatigue point breaks the stem to complete shear.

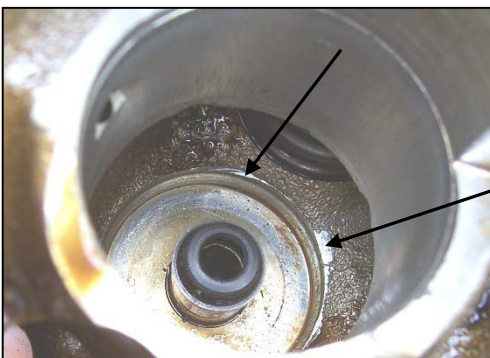
Note burnish/polish mark witnessing incorrect spring seating.

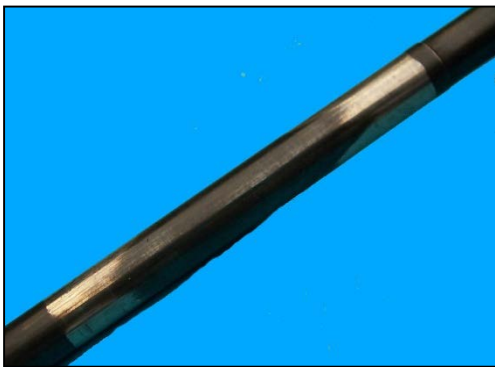
VALVE GUIDE WEAR

Valve and stem exhibit polished contact faces but tending to each end of the stem travel length.

General wear and tear plus various causes

- a) Excessive oil by pass leading to valve and seat carbon fouling. Engine breathing and performance will be reduced and "blue smoke" will emit from the exhaust. Ultimately the valve will foul to the point of non-closure.

- b) Since a worn guide allows valve freedom, the valve head is not constrained to its pre-determined axial direction and valve "cocking" will occur. As the valve approaches closing, it hits the seat on one side followed by closure on the opposite side i.e. it double hits and bounces. This puts enormous point loading on the valve head and throat and fatigue breakage is possible at the true stem start.

- c) Valve "cocking" as above will ironically accelerate wear both to the valve stem and the guide. Side loading is now concentrated to both ends of the guides instead of the designed bore length. Although the oil film has increased, the oil barrier has to combat the hammering effect, as opposed to the designed sliding effect and metal to metal contact can occur. Additional wear will result on stem and guide.
-

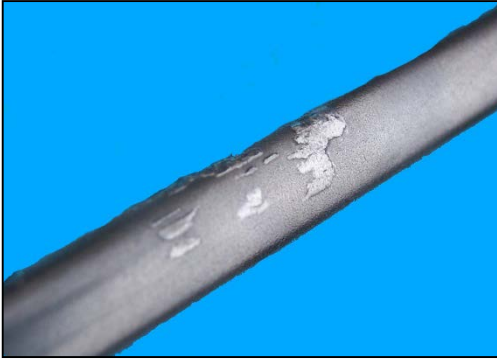
VALVE GUIDE PICKUP

Raised tongues of metal adhered to the stem with possible associated line scoring.

a) Insufficient clearance following an overhaul or b) Insufficient lubrication on assembly.

a) Insufficient clearance will result in an immediate valve seizure/pickup, normally within two minutes of engine start up. As the valve expands the oil barrier is excluded and metal to metal contact ensues. The frictional effects will tear tongues of metal normally away from the valve guide bore and these will molecularly adhere to the valve stem. An overlapping of tear off tongues can cause an interference seizure in either open or closed position. Piston and valve collision might result or even rocker arm breakage, whatever, the engine will fail. If the adhesions act as a key and keyway and the valve doesn't seize, problems will still occur. Since the valve can no longer spin (which helps with load distribution and self-cleaning of the seat faces) then the non-spin factors will dramatically shorten the valve life.

b) During cylinder head assembly both valve stems and valve guide bore should be liberally coated with a high viscosity oil or with a pure graphite black grease like "Graphogen". DO NOT lubricate with light oil such as A.T.F. and DO NOT lubricate with white grease. Always attain oil pressure and visual flow of oil at starter revolutions before engine is fired. Allow sensible running in periods for all new components.

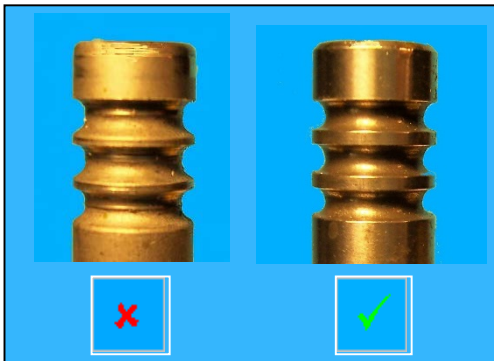
COTTER GROOVE WEAR

Either valve or cotter male beads are worn. Thin cotters will move up and down the stem when "freely" assembled. Note the cotter beads on the left hand image are very thin compared to the good valve on the right.

a) Normal wear and tear.

b) Valve hammer due to excessive valve clearance.

Valve cotter grooves and indeed the cotters themselves must be inspected for wear. Worn cotter clearance can impose shock loads which can lead to further rapid cotter wear and possible shear.

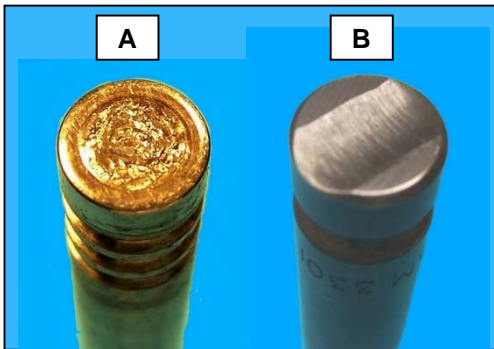
VALVE STEM ENDS

Stem end is not flat

- a) Fatigue pitting. Possible breakthrough of hardened surface.
- b) Rocker arm trough preventing valve spin.

Normal wear and tear.

It is acceptable for an engine repair shop to reface a stem end known as "topping" however care must be taken not to;

- 1) Grind off too much or the hardened surface can be removed.
- 2) By lowering the stem too far the camshaft follower or rocker arm can contact the valve cap rather than the stem end and a dropped valve might result.
- 3) In respect to hydraulically operated systems (i.e. hydraulic cam followers) particular detail to valve protrusion heights must be strictly observed and maintained.

WARNING! DO NOT strike valve stem ends with steel hammers to "set cotters". A light blow with a plastic faced hammer is acceptable.
